# LDS2006A Pulpit/Podium Lift

Replacement for older Gifford/Pulpit Man Lifts

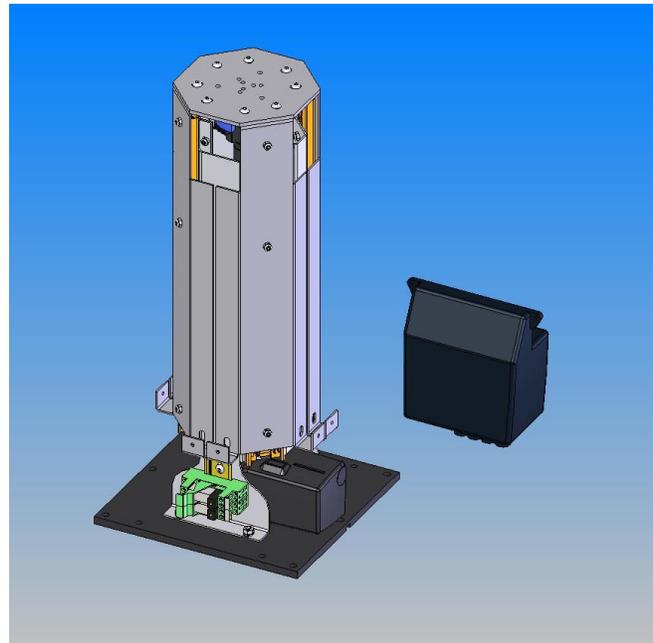
The LDS2006A system includes the complete lift assembly and control box (shown at the right). This lift will fit inside the neck of the pulpit of any Gifford/Pulpit Man lift that is between 6-1/4" and 6-1/2" square (inside dimension). If the neck of the pulpit lectern is different than these dimensions please provide pictures of the pulpit cabinet and dimensions of the neck and I will provide instructions on how to proceed.

This design standardizes the look, feel, operation of, and components of all of the lifts across the board. Compare the figure on the right to the one on the first page of this document so the see the size difference.

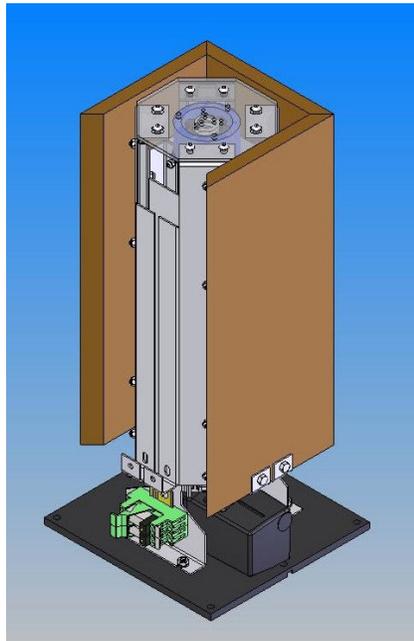
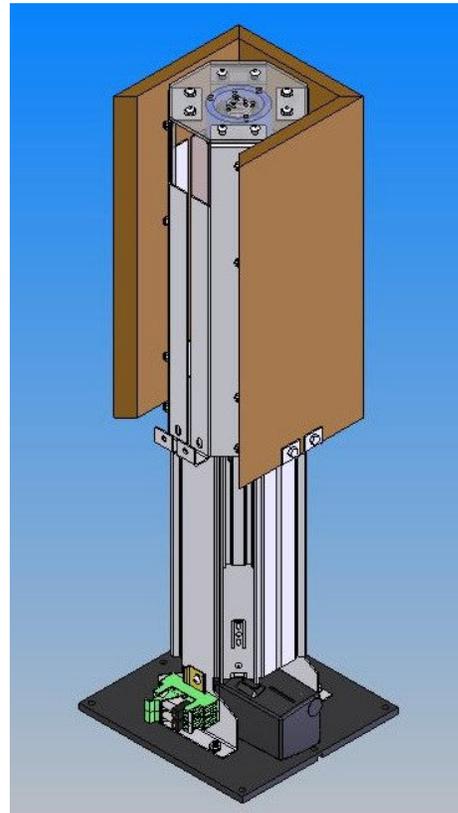
The following illustrations show the lift retracted and extended (three sides of the lectern neck are shown.)

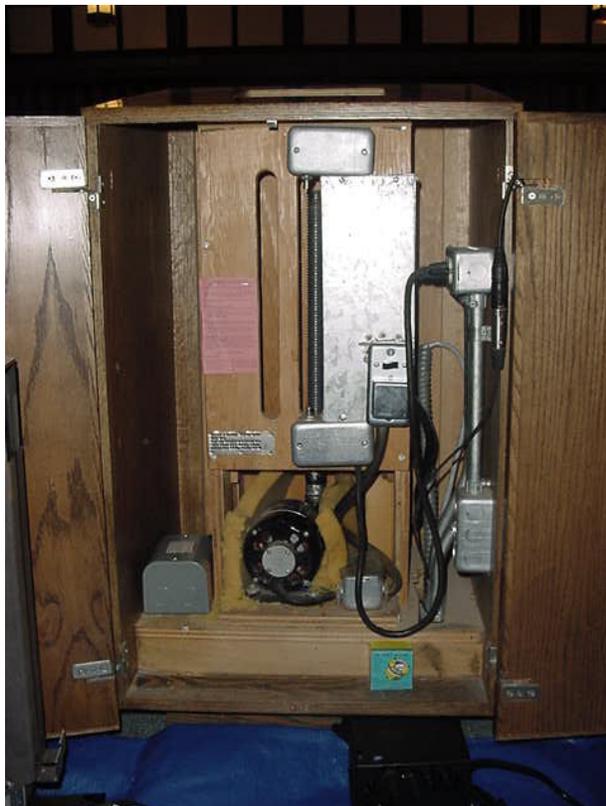
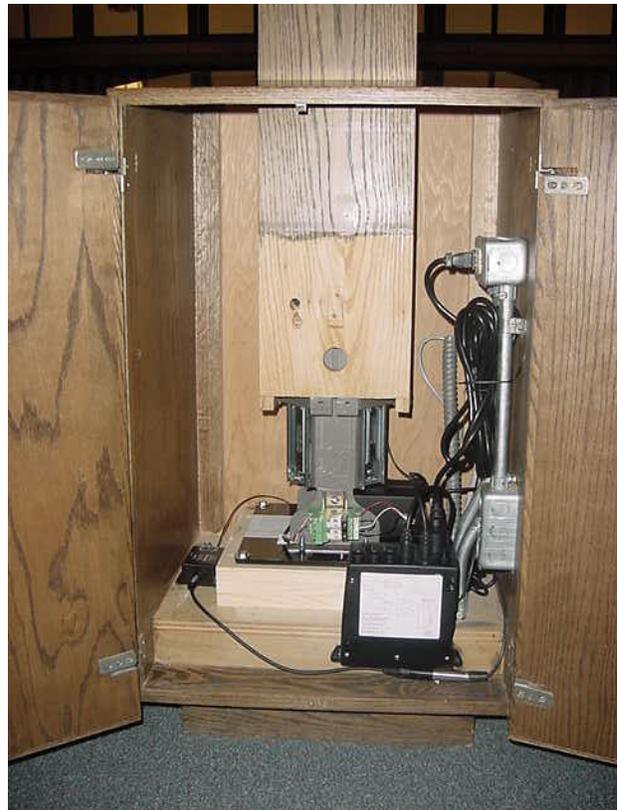
These photos show a pulpit before and after upgrading. (No cabinet modifications required).

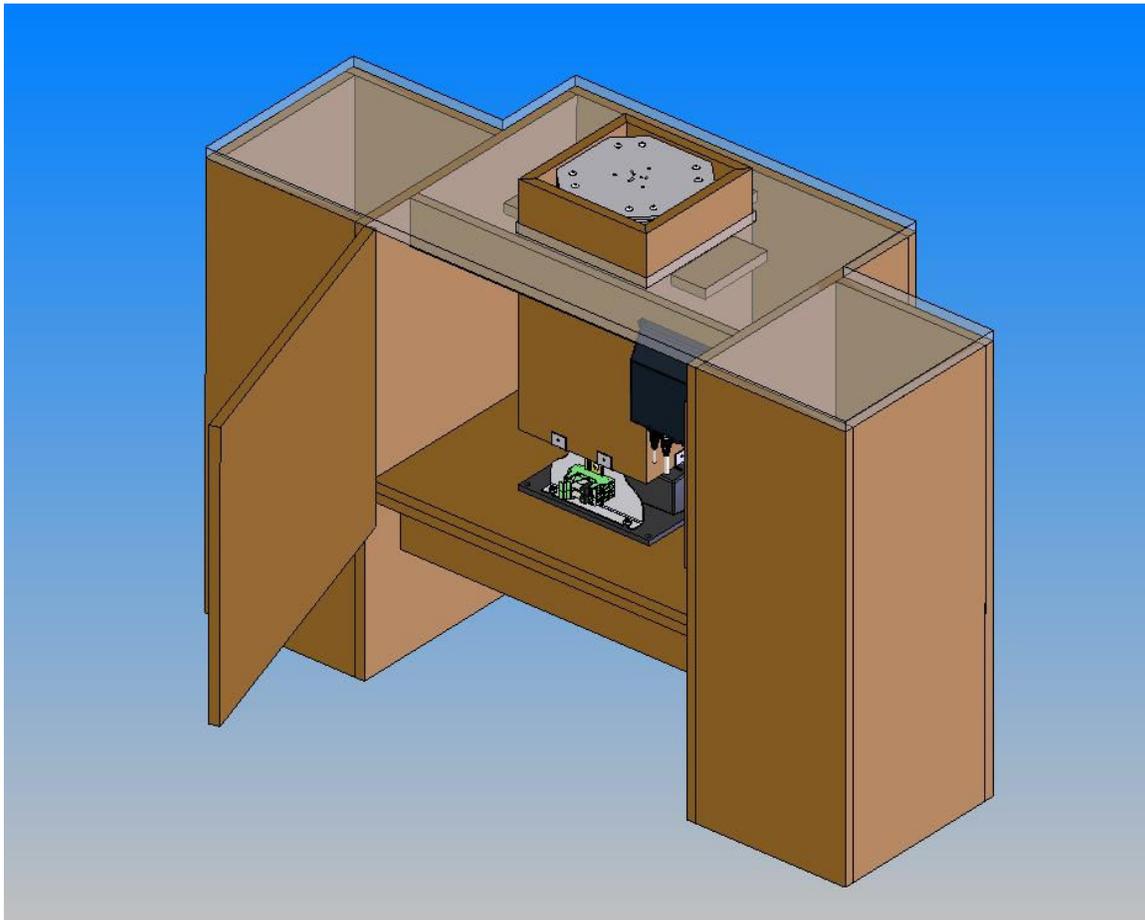
This following figure illustrates a generic podium cabinet with the LDS2005A pulpit lift installed in the cabinet. The black box in the upper right-hand corner of the cabinet is called a CB9. This control box processes the up and down input signals from the Bishop's Control Panel (CP-884) and converts them into an output signal that runs the lift up or down.

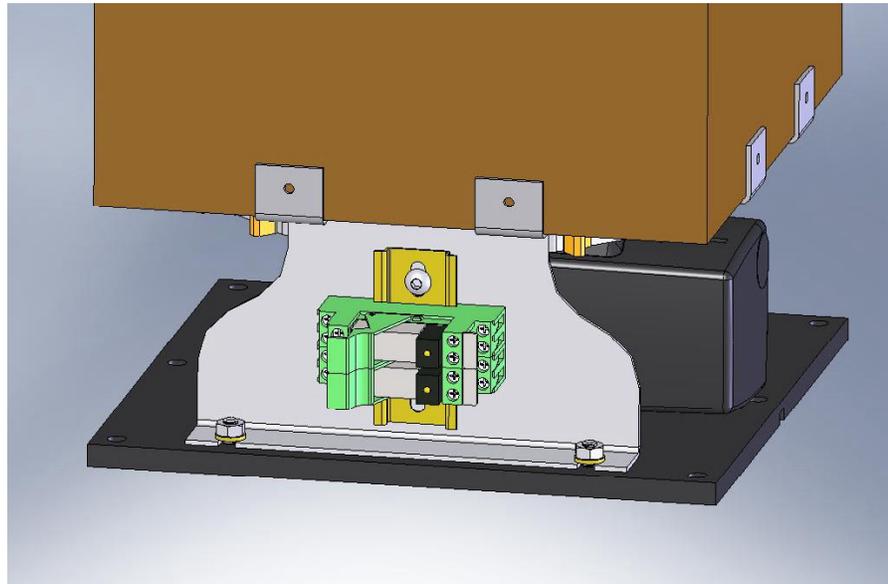
In this figure you can see the two green and white relays mentioned on the previous page in more detail. The Electrician in the field connects three wires from the Bishop's control panel to the four screw clamps, located closest to the center of the figure in a vertical row. Just to right of these four screws are two rectangular white marker tabs. In the field these marker tabs are labeled as follows (reading from the bottom up): The bottom marker tab is labeled "C UP" while the top marker tab is labeled "C DWN". A "common" wire is run from the Bishop's control panel (CP-884) to the screw clamp labeled "C" on the bottom relay and then it is looped up to the screw clamp labeled "C" on the top relay. A second wire is run from the "UP" connection on the CP-884 to the screw clamp on the bottom relay labeled "UP". A third wire is run from the "DOWN" connection on the CP-884 to the screw clamp on the top relay labeled "DWN".

If connected properly the little yellow LED on each relay will light up when the appropriate UP or DOWN button is pressed on the Bishop's control panel (CP-884), and the pulpit will raise or lower accordingly. The CP-884 outputs a 24VDC signal to operate these relays. In Figure 2, located directly behind the green relays you can see the black motor housing of the LA31 lift mechanism.

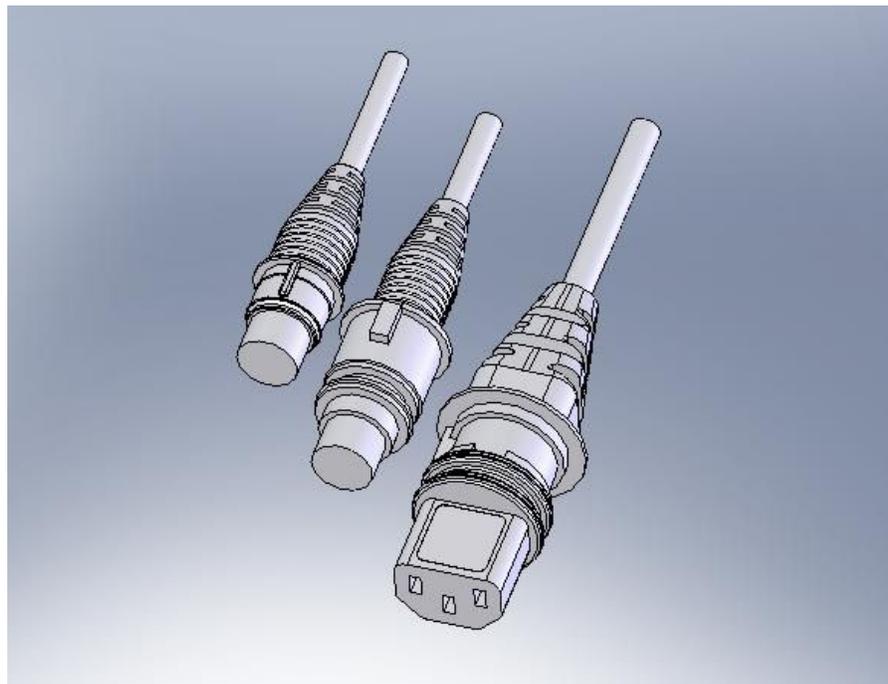
Three cables are plugged into the CB9. These cables are all sized and keyed so they can only be installed in one place. One large cable is the AC power cord and plugs into a square white surge cube which then plugs into a 120VAC outlet. This outlet is installed in the pulpit cabinet, in the field by an Electrician. A second cable runs up into the pulpit lift to the safety and back down to the left side of two green control relays. A third cable runs from the CB9 to the black LA31 lift motor located in the center of the pulpit lift.

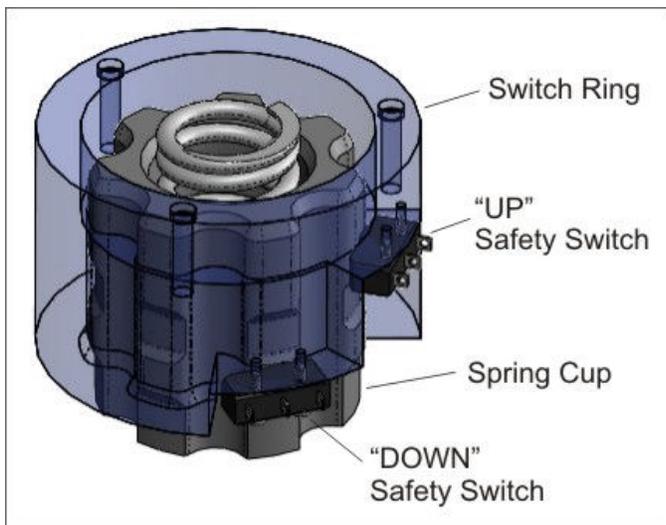
In the figure below you will see the Safety Assembly. In the center of this assembly is a compression spring. This spring is contained within a lobed part called a Spring Cup. The Spring Cup is manufacture from a black plastic. The outside ring of this assembly (shown transparent here for illustration purposes only) is called the Switch Ring. In reality, the switch ring is manufactured from a black or blue plastic. It is called a Switch Ring because two black limit switches are mounted to it. The switch located in the picture half way up toward the right side, is used to stop upward motion. It is activated if the pulpit is overloaded (more then 50 lbs). When overloaded the pulpit lift will not run up or down. The switch located in this picture, in the center, toward the bottom, is the switch used to break downward motion. This switch is activated if the pulpit pinches an object. In this case the pulpit will not run down but will still run up to release the object that is pinched. Please refer to the "Installation and Troubleshooting Guide" shipped with the pulpit for more details.

A multi-conductor cable runs from this unit to the CB9 control box and to the left side of the green relays.

The switch shown above (Safety Switch 4) was installed on lifts produced from 2004 through 2007. In 2007 the switch design change to improve field adjustment. The following two illustrations show the design (Safety Switch 5) produced from 2007 through 2009.

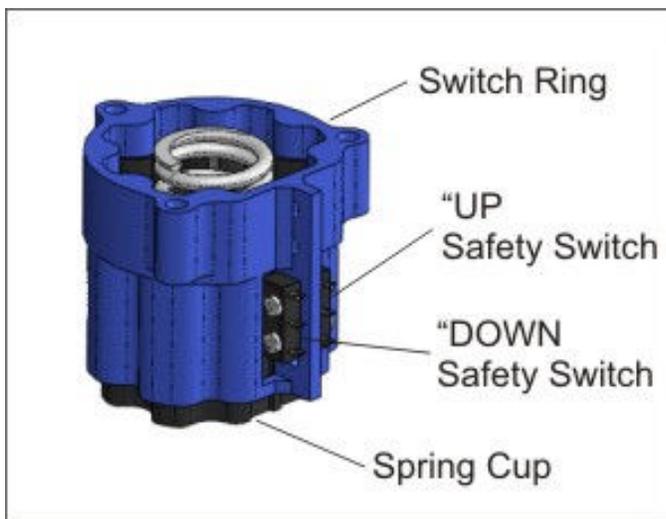
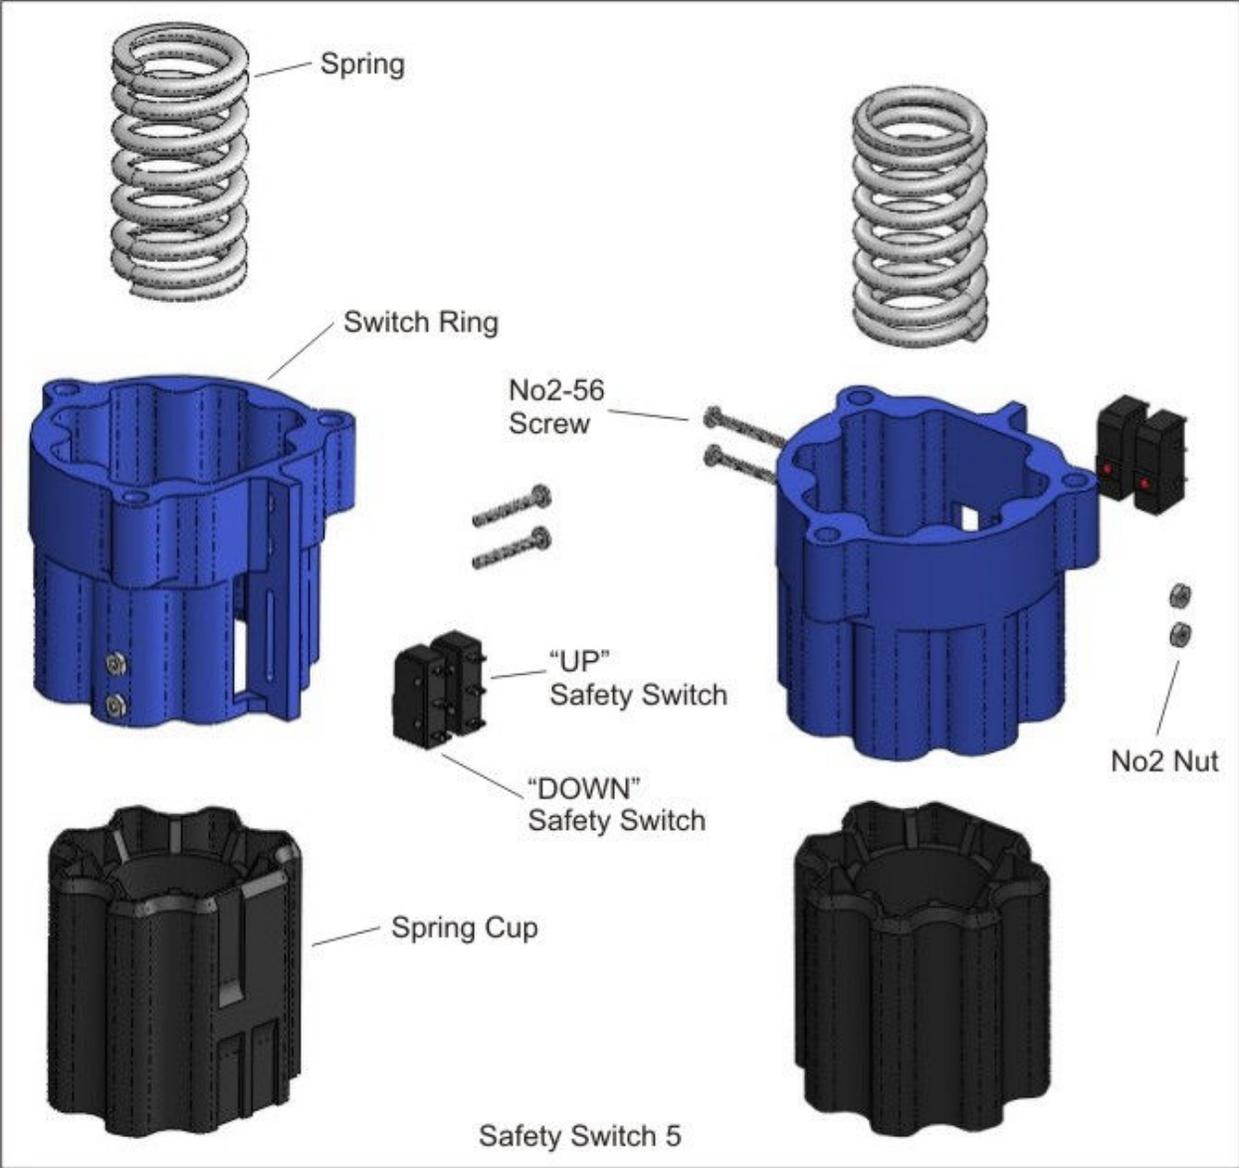
This safety switch was manufactured on a 3D printer and has a ribbed texture on the blue and black parts.

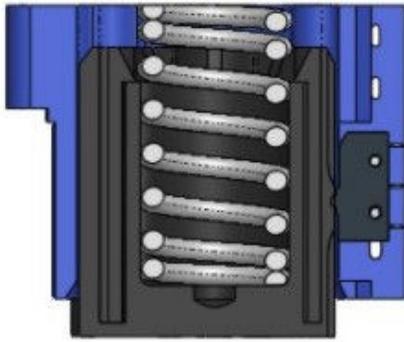
Std. Switch Position

The illustration to the left displays several cross-sections of the safety switch assembly. Each cross-section displays a function state of the safety switch.

The first cross-section shows the safety switch assembly in the “normal” operating state. Note how the lobe on the right side of the spring cup holds the button of the safety switch closed. In the state the lift will run up and down.

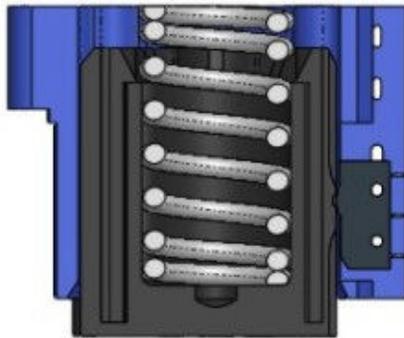
Alt. Switch Position

The second cross-section illustrated an alternate method of installing the safety switches. Note that the switch units are located “up-side down”. Both the UP and DOWN switch must be installed in the same orientation. This method of installation allows the button of the switch to be located close to the top of the switch ring. This type of installation is typically used for heavy lectern/neck assemblies.

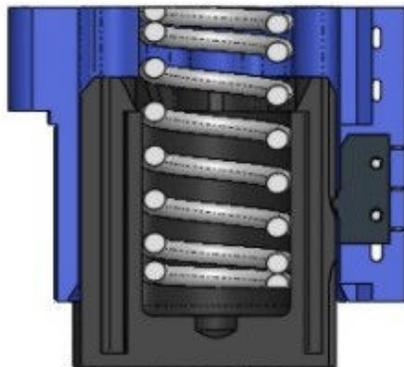
Pinch Position

In this cross-section you can see that the gap between the top of Switch Ring (blue part) and the top of the Spring Cup (black part) is larger than shown in the previous cross-sections. This is the case in a “pinch” situation. In this state the lobe of the Spring Cup that normally holds the DOWN switch closed is now below the switch button. The switch is now OPEN and the lift will not lower. However, it will still rise to release the “pinched” object.

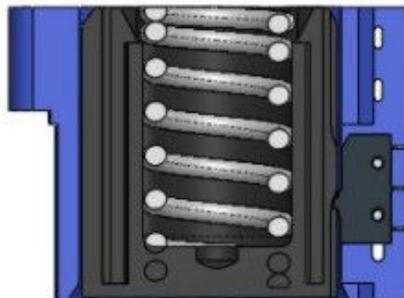
Overload Position

In this cross-section you can see that the gap between the top of the Switch Ring (blue part) and the top of the Spring Cup (black part) is gone. This is the case in an “overload” situation. In this state the lobe of the Spring Cup that normally holds the UP and the DOWN switches closed is now above the switch button. The switch is now OPEN and the lift will not raise or lower. However, once the overloading weight is removed from the lectern the safety switch assembly will automatically reset.

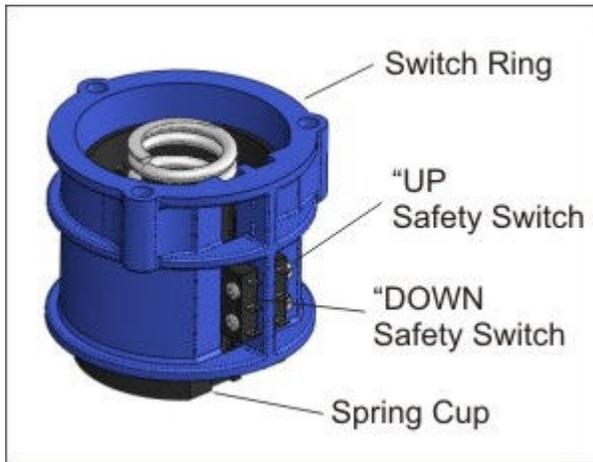
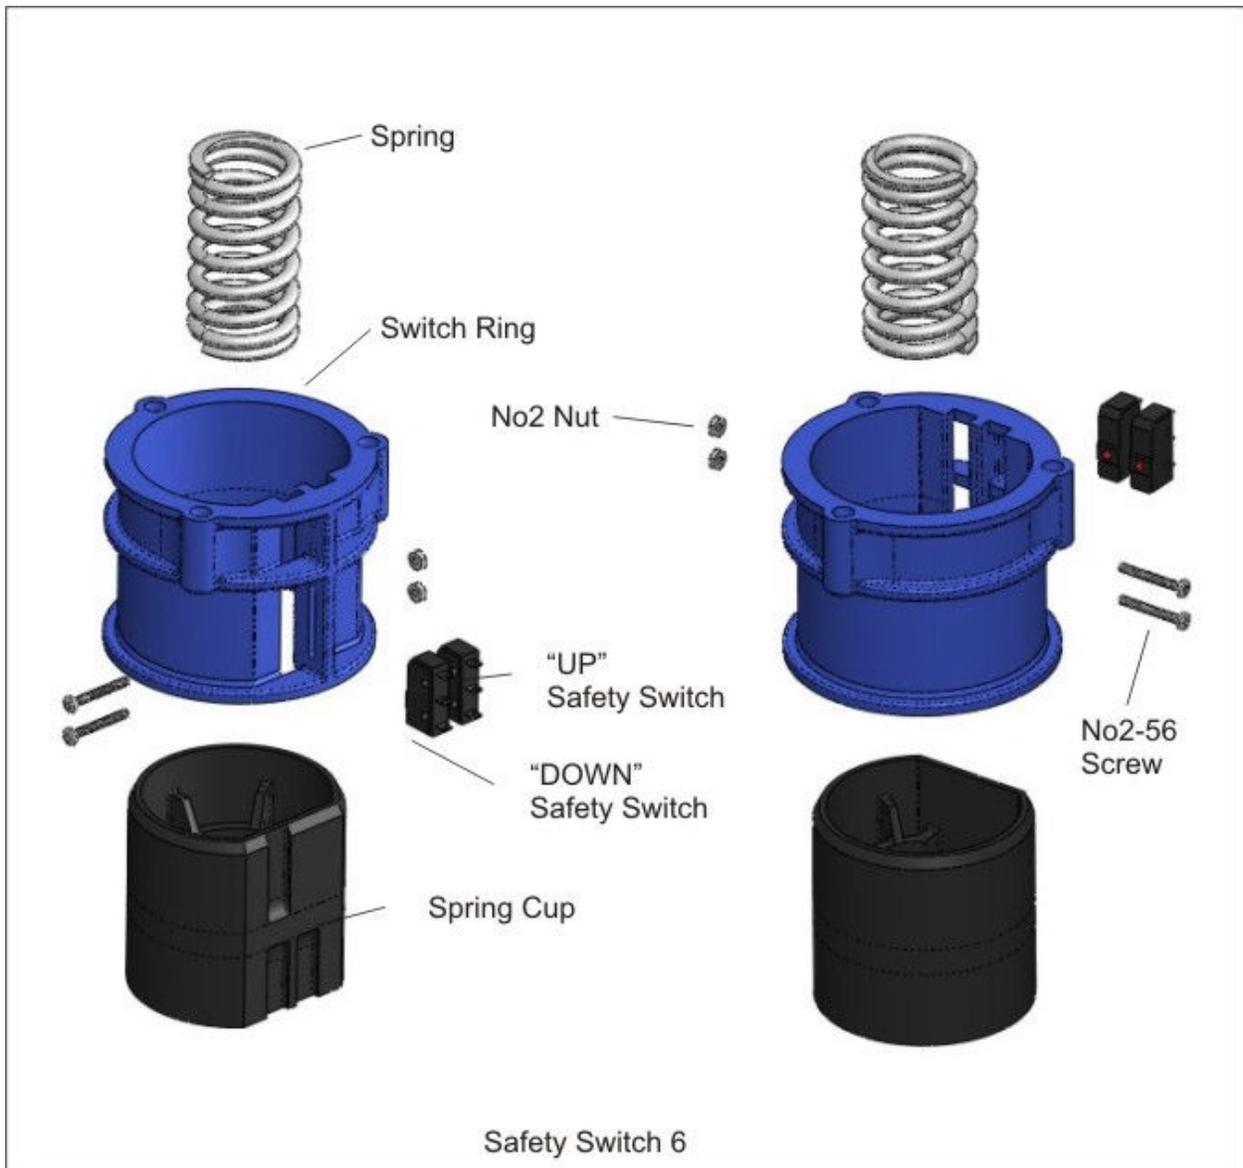
In 2010 the Safety switch was changed to a design that could be injection molded. This design (Safety Switch 6) is shown below. Its operation is the same as Safety Switch 5.

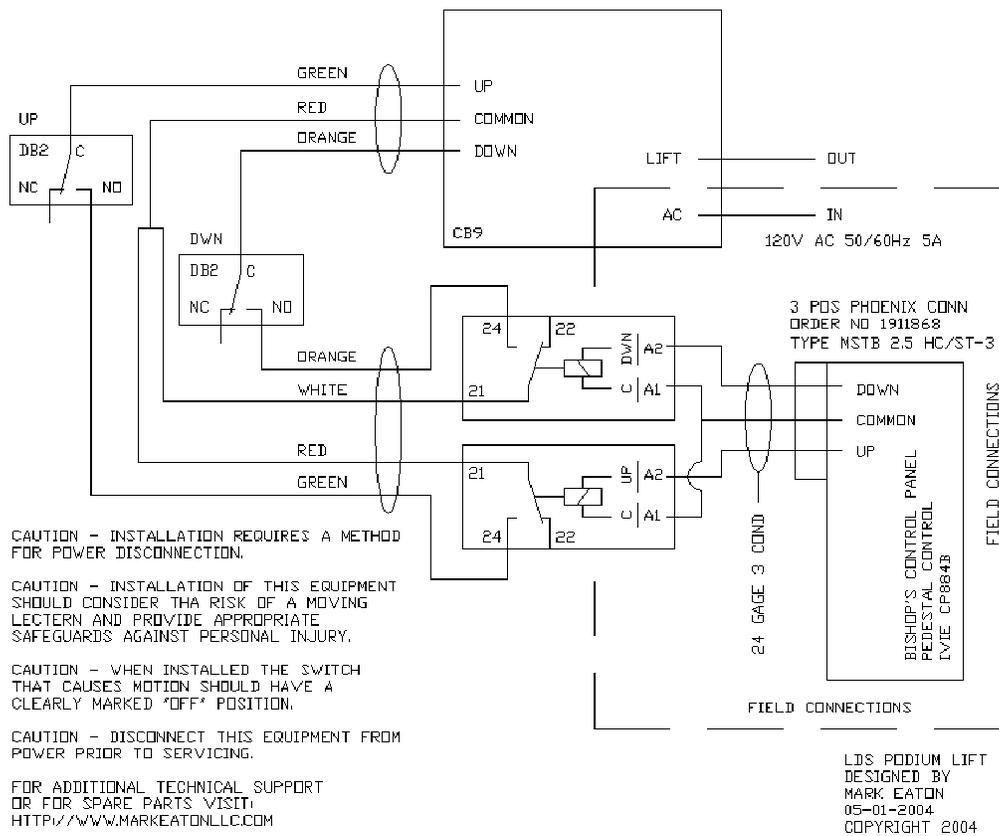
This figure illustrates the electrical connection diagram. A copy of this diagram is affixed to the CB9 control before it is shipped into the field for installation.

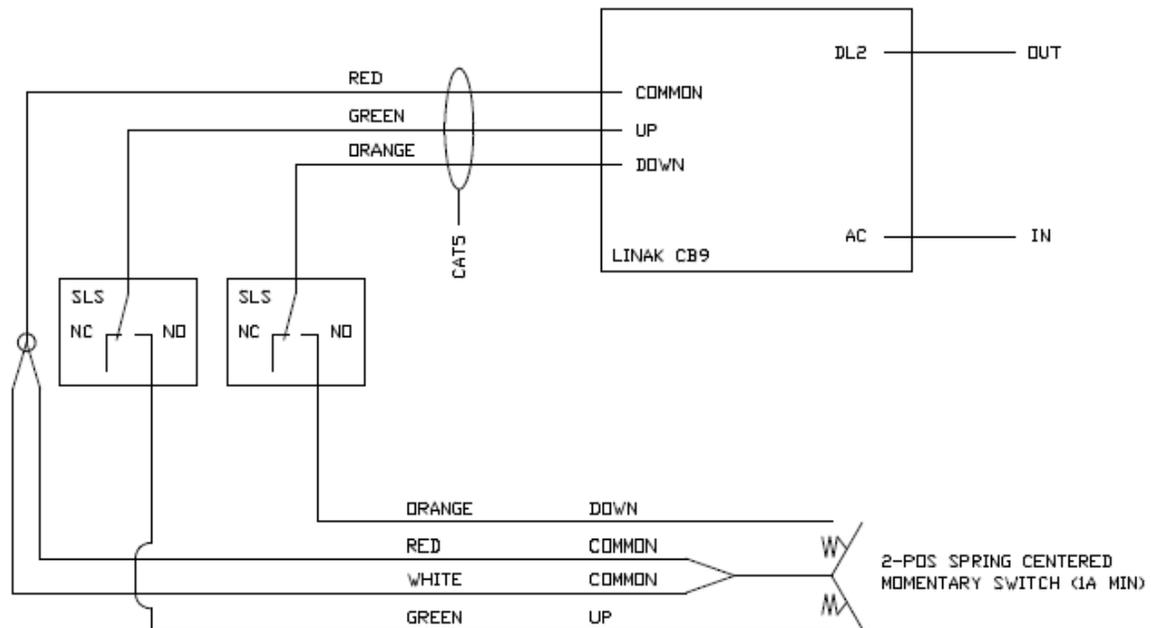
The following figure illustrates the electrical connection diagram for operating the lift with a rocker switch.

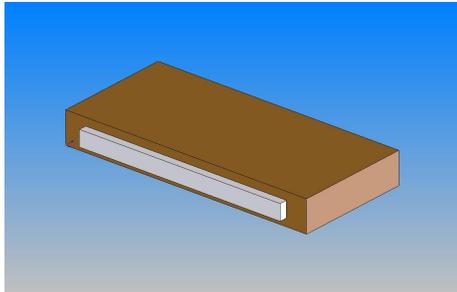
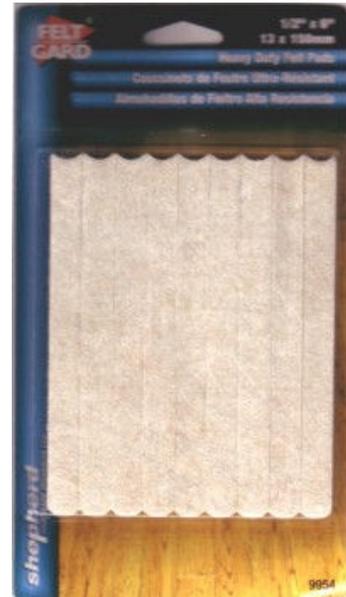
Purchase a package of “Felt Gard” 1/2"x6" Heavy Duty Felt Pads manufactured by Shepherd, part number 9954, from Home Depot. See the illustration on the right.

Attach one pad to the edge of a 1"x2"x8" oak (or other solid hardwood) board. For LDS2005A retrofits you will need to cut the boards 1"x 2" x 10". You will need to make up four of these board-pad assemblies. See the illustration below.

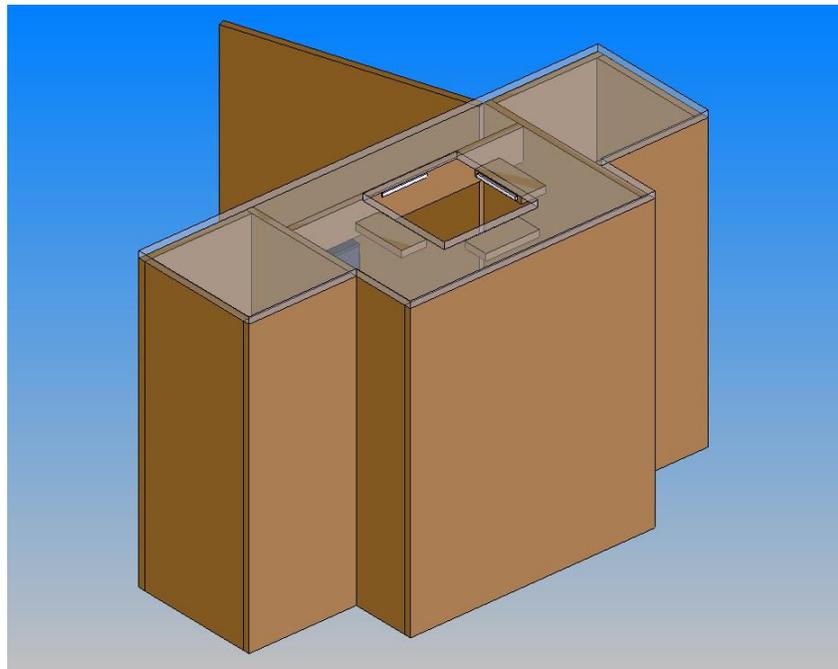
The illustration to the right shows an example of the pulpit cabinet with the lectern, neck, and lift removed. The top of the cabinet is transparent for the purpose of illustrating where to place the felt pads and the board-pad assemblies described earlier.

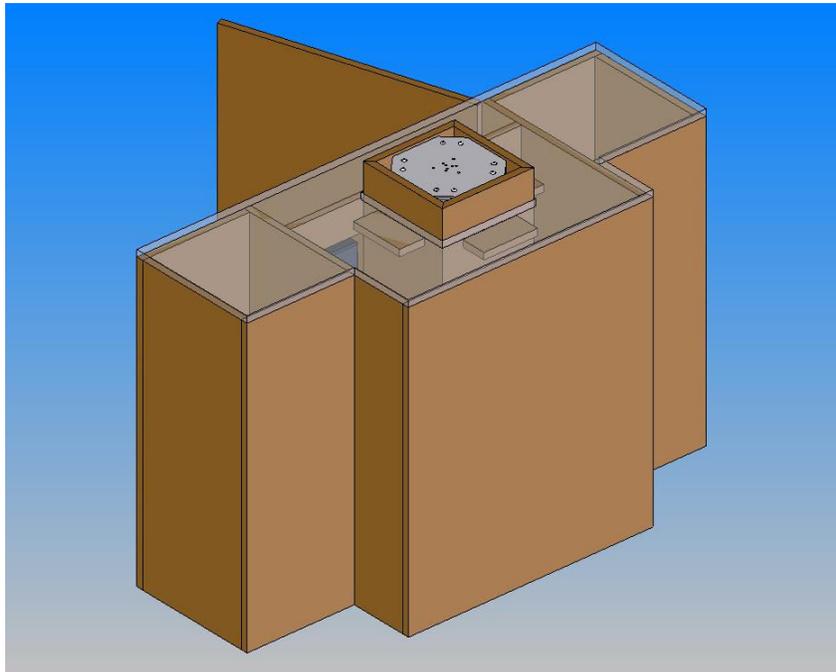
With the lift, neck, and lectern re-installed - place the board-pad assemblies described earlier in position on each side of the lectern neck as shown. Attach these to the bottom side of the cabinet top with grabber screws.

DO NOT push these blocks against the neck too tightly. If they are too tight they will activate the pinch sensor and the lift will not lower.

DO NOT position them too loosely or they will not have the desired effect and may even chatter as the lectern moves up and down.

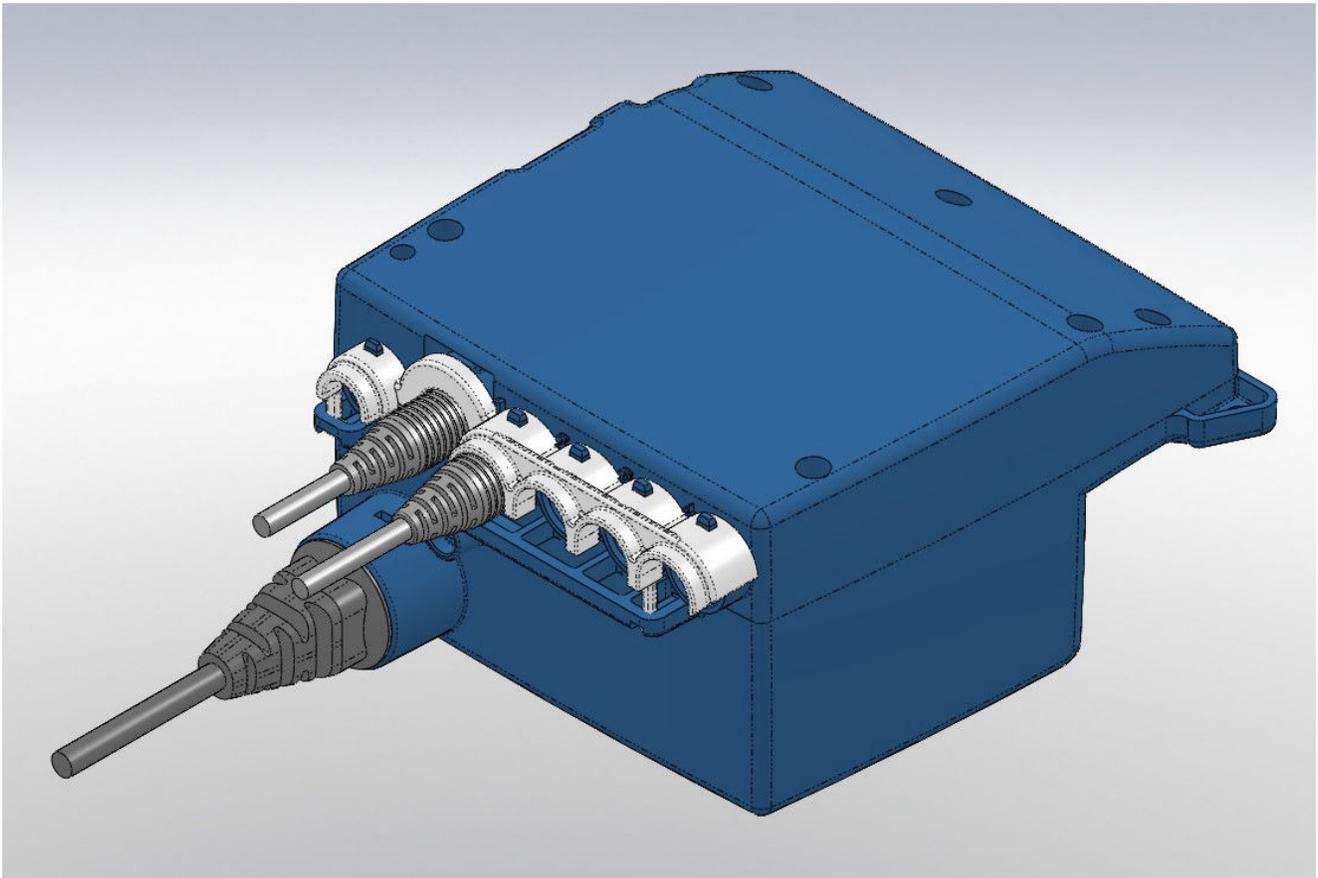
The part shown in blue is the CB9 control box.

The part shown in white is the cable restraint. It locks to the CB9 in three locations. This part must be installed to prevent the cords from being pulled out of the CB9 accidentally.

The three parts shown in gray are the power cord (large), safety switch cable (medium), and motor cable (small).

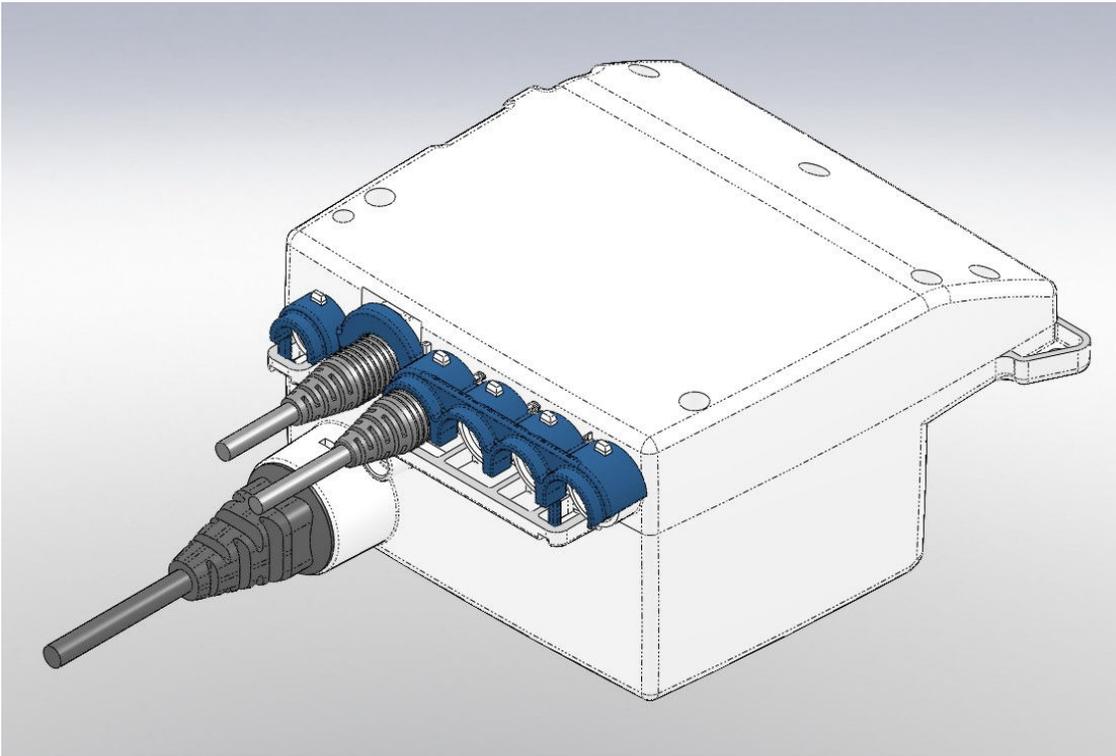
Cord restraint (shown in blue) installed.

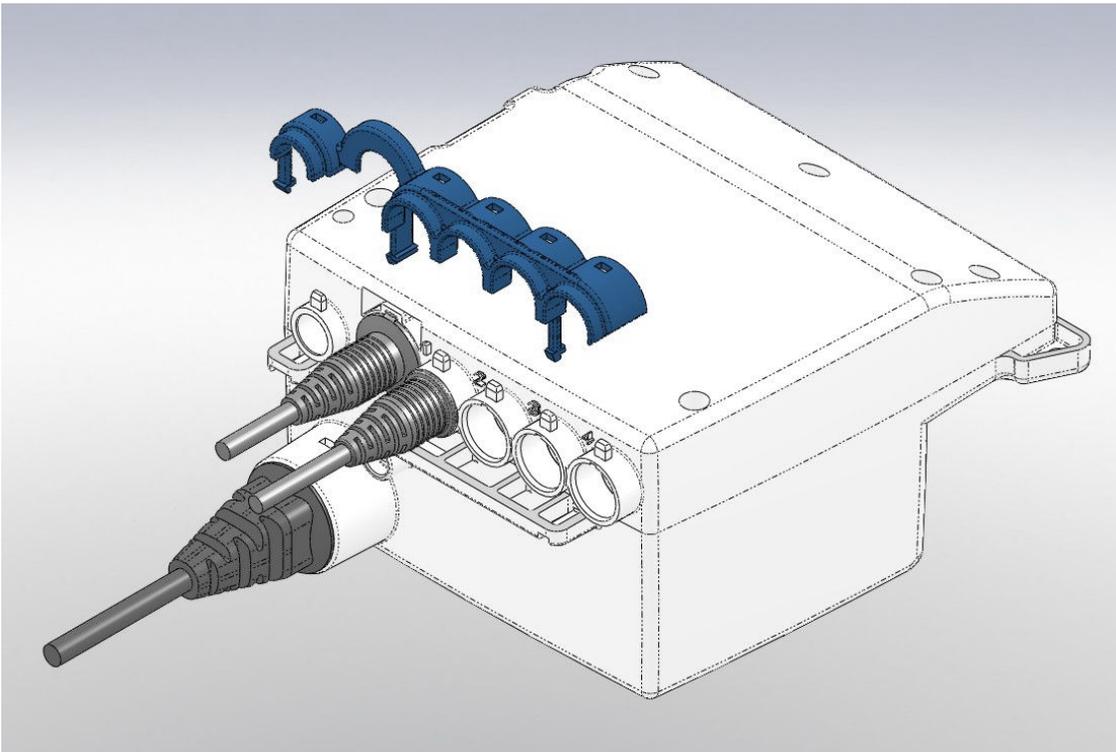
Cord restraint (shown in blue) removed. Note the three locking tabs.  
Common Problem: Service Tech cannot figure out how to remove this part and cables are damaged during a repair.

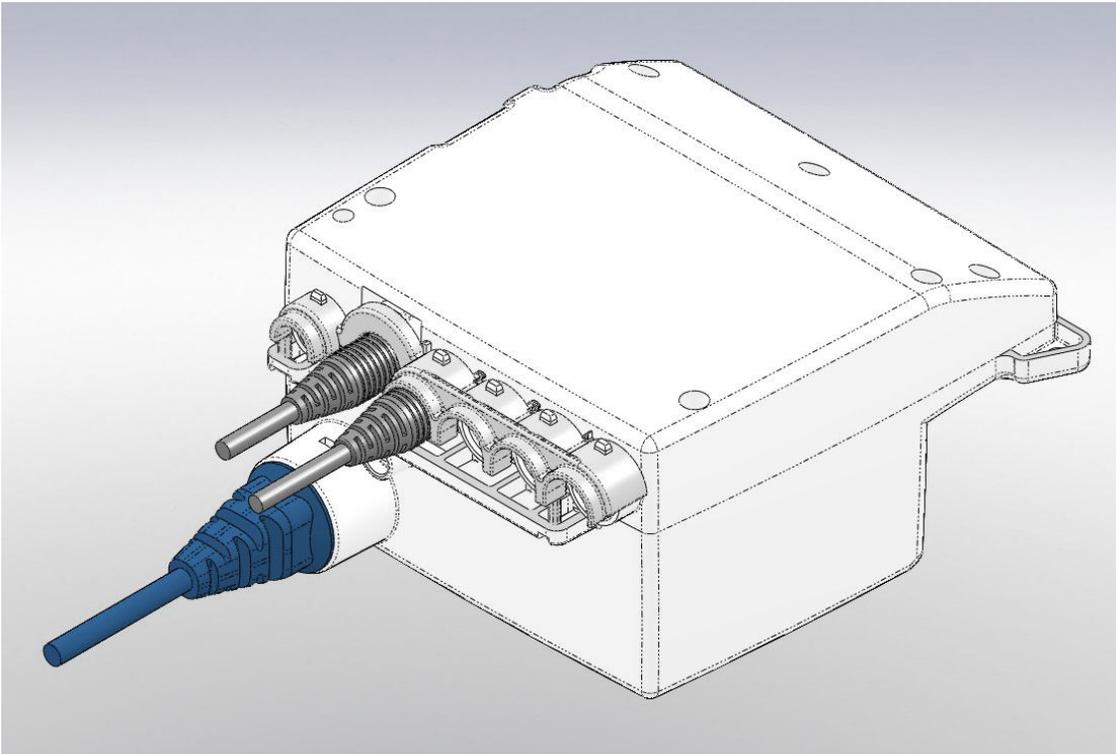
Power cord (shown in blue) installed.

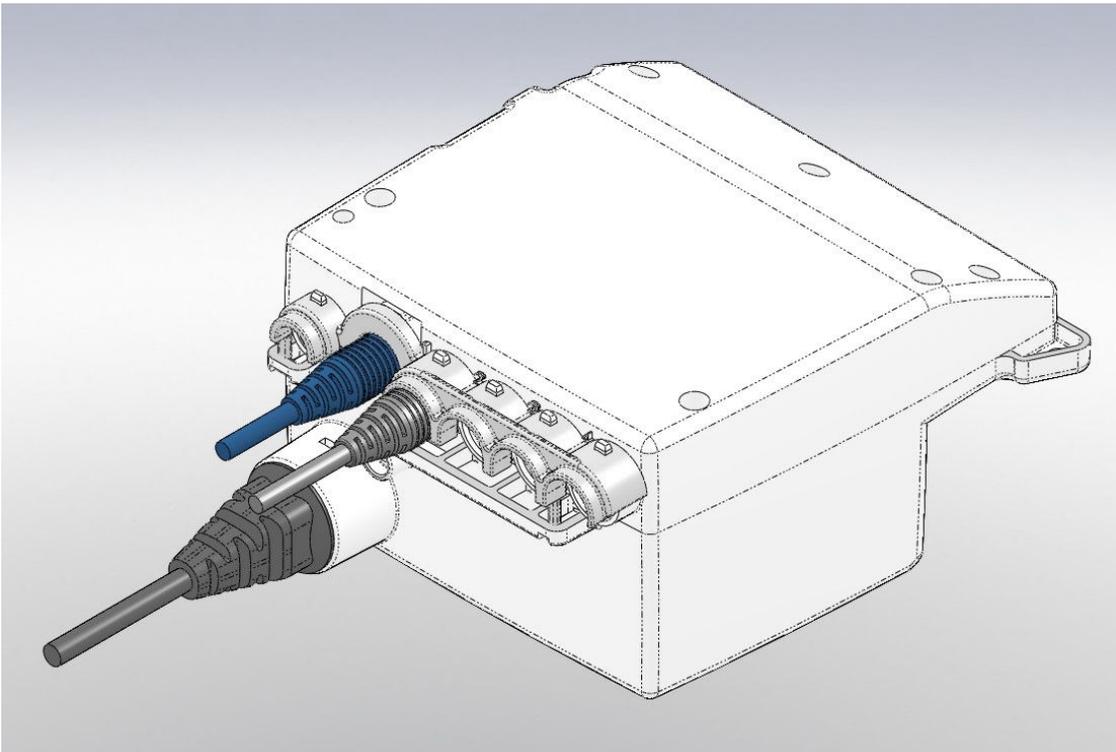
Safety Switch Cable (shown in blue) installed.  
Common installation problem: Not plugged in completely.

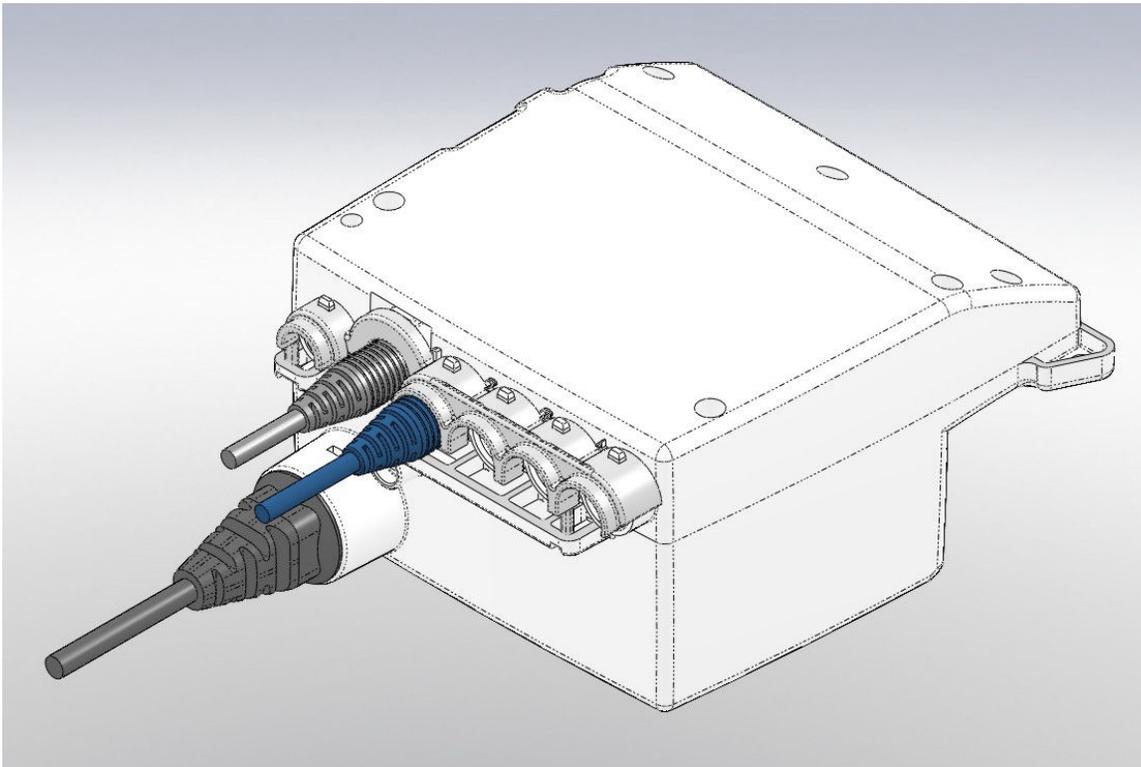
Motor cable (shown in blue) installed.  
Common installation problem: Not plugged in completely.
